# Above the Flood: Elevating Your Floodprone House

FEMA 347/ May 2000

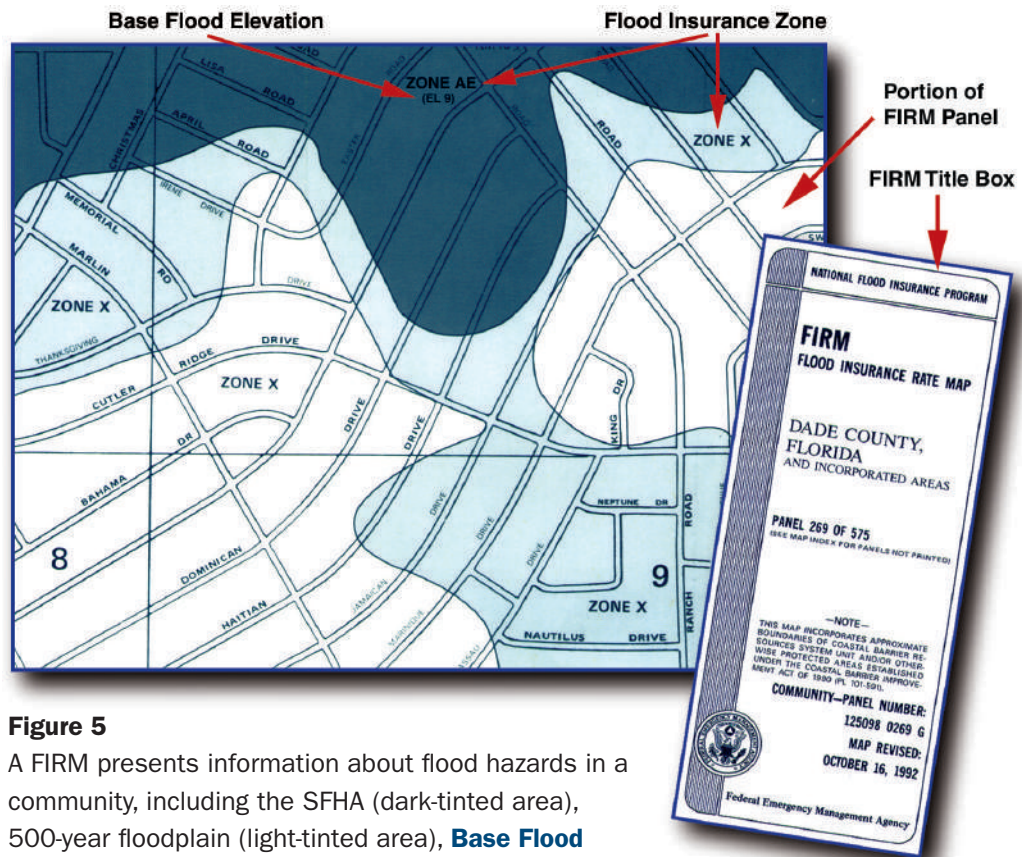
**Figure 5**

A FIRM presents information about flood hazards in a community, including the SFHA (dark-tinted area), 500-year floodplain (light-tinted area), **Base Flood Elevations**, (BFEs) (number in parentheses), and flood insurance zones (AE and X in this example).

Note that the SFHA in the example in Figure 5 is designated Zone AE. This zone is only one of several applied to SFHAs under the NFIP, including V, VE, V1-V30, A, AE, A1-A30, AO, and AH. These zones indicate differences in the types and severity of flood hazards in SFHAs. For the purposes of this publication, it is sufficient to focus on the basic differences between the two main types of SFHA zones—V zones and A zones. The distinction is important because regulatory requirements associated with V zones and A zones differ significantly. As explained later in this chapter, these requirements affect the types of building elevation techniques that may be used under the NFIP.

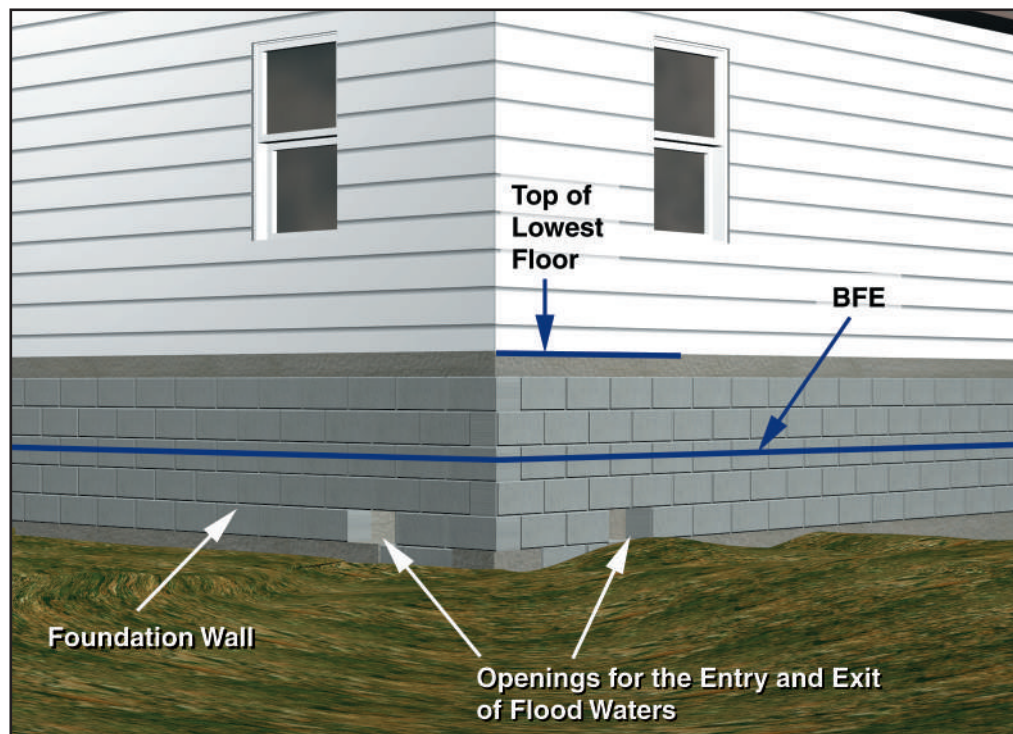
**Figure 6**

In a new, substantially improved, or substantially damaged building in an A zone, the elevation of the lowest floor must be at or above the BFE.

In A zones, where flood hazards are less severe, buildings may be elevated either on an open foundation or on continuous foundation walls below the BFE (Figure 6). Regardless of the type of foundation used, A-zone buildings must be elevated so that the **lowest floor** is at or above the BFE, as shown in Figure 6. If continuous walls are used below the BFE, they must be equipped with openings that allow flood waters to flow into and out of the area enclosed by the walls (Figure 6). Allowing the entry and exit of flood waters ensures that water pressures will be the same on both sides of the walls and reduces the likelihood that water pressure will cause the walls to fail.

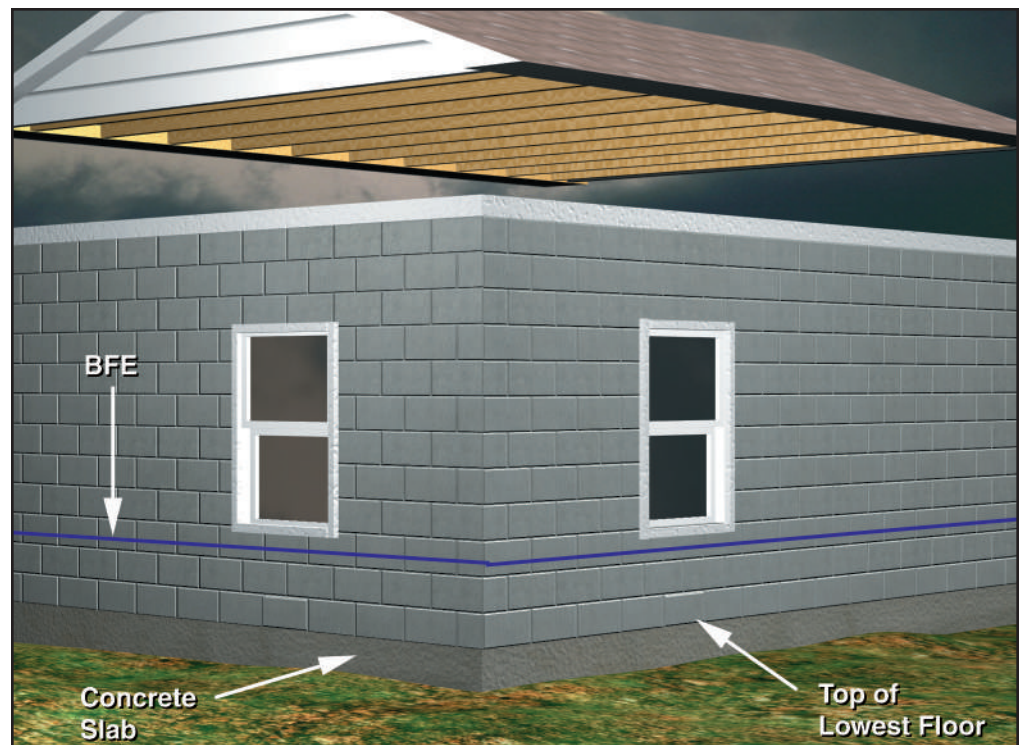
**Figure 10**  
The first step in Technique 1 is removing the roof.

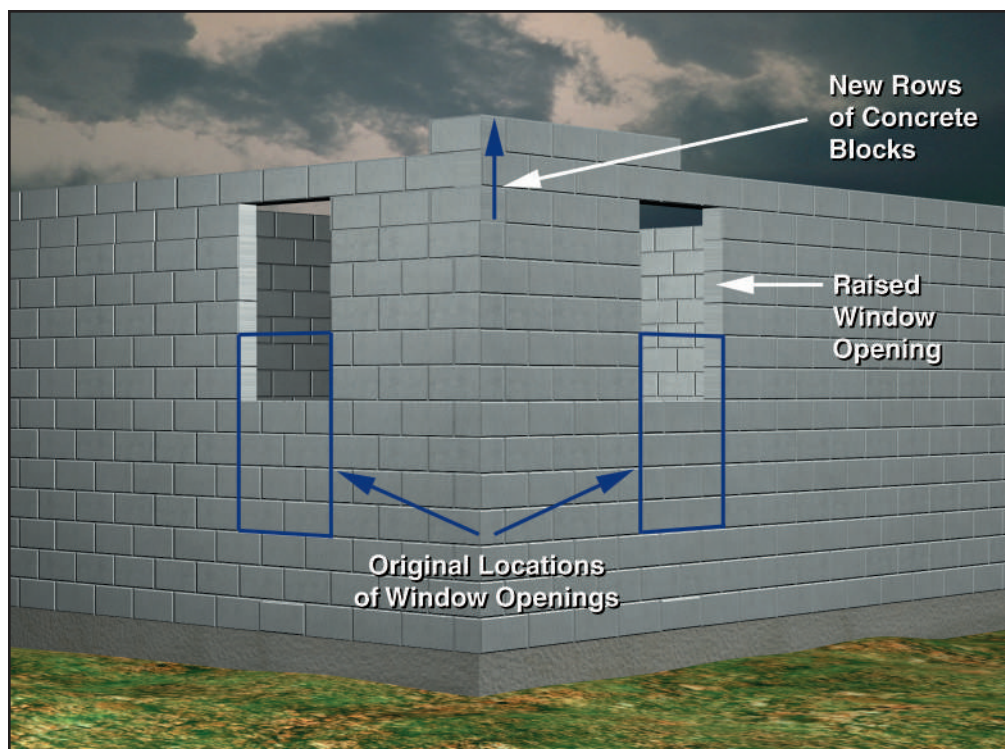
The tops of the walls and bottoms of the window openings are raised with concrete blocks.

After the roof, windows, and doors are removed, several courses of concrete block are added to the tops of the existing walls and to the bottoms of the window openings (Figure 11). A corresponding number of blocks are removed from the tops of the window openings so that the size of the windows will remain the same. In addition, although not shown in Figure 11, concrete bond beams are formed in place at the tops of the extended walls to provide structural reinforcement.

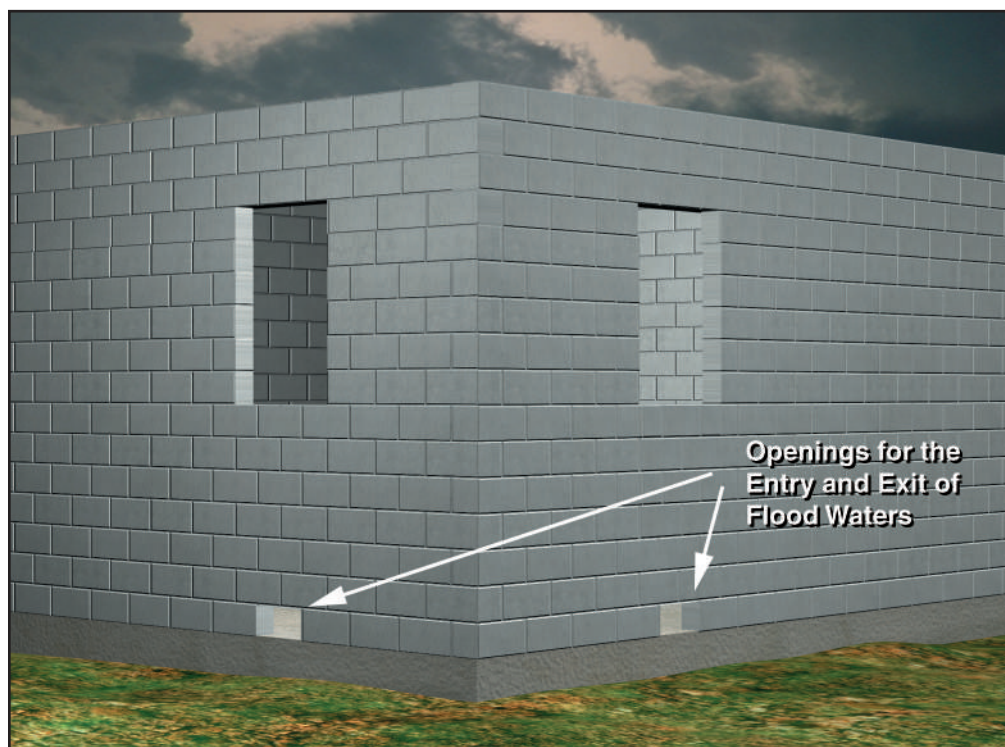
**Figure 12**  
Openings are created  
in the walls near the  
ground.

Blocks are removed from the walls of the house at selected locations within 1 foot of the ground (Figure 12). The resulting openings will allow flood waters to flow into and out of the lower area of the house so that the water pressures on both sides of the walls will remain the same. The roof and windows are then replaced, and a new wood-frame floor is constructed above the flood level (Figure 13).

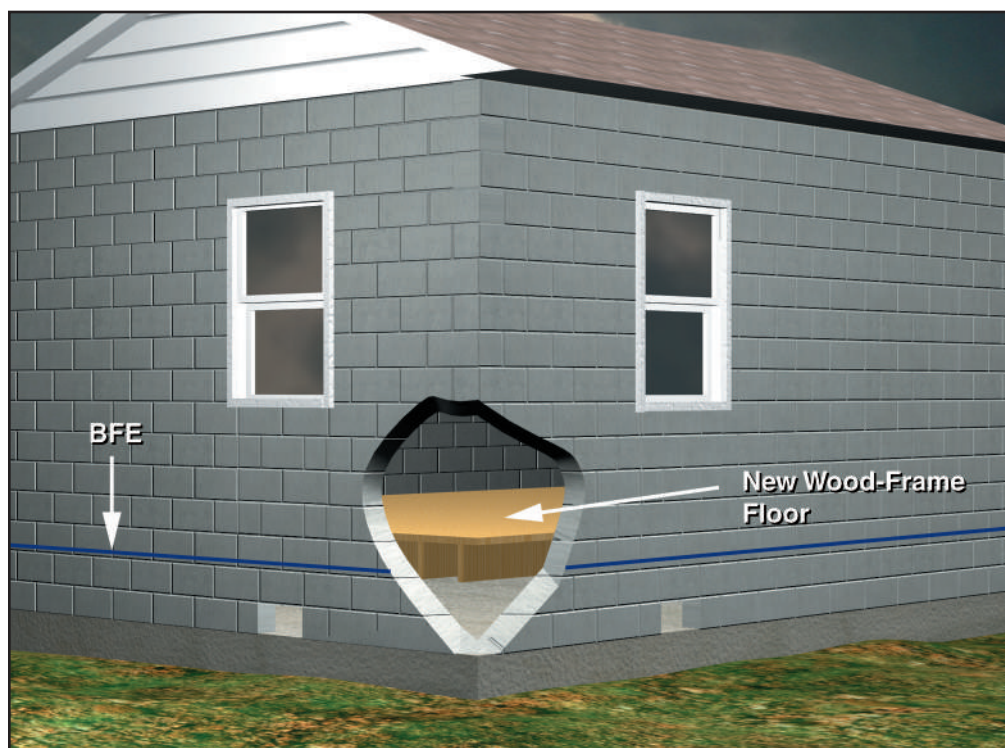
**Figure 13**  
A new wood-frame  
lowest floor is  
constructed above the  
flood level, and the  
roof, windows, and  
doors are reinstalled.

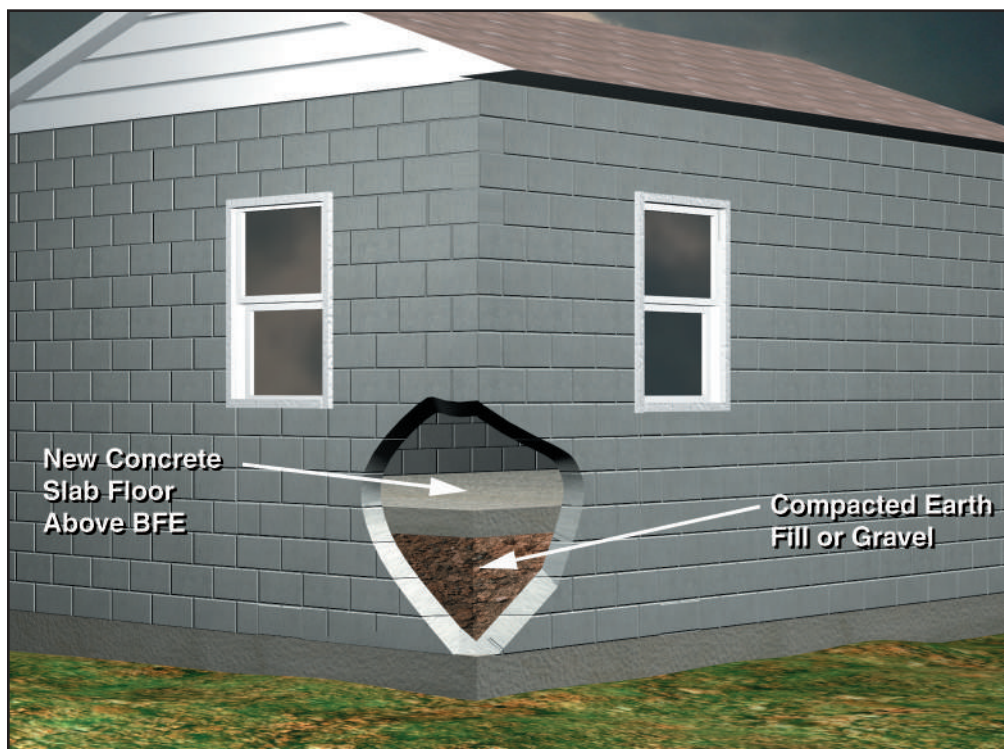
**Figure 14**  
An alternative to building an elevated wood-frame floor is installing a new, elevated concrete slab floor on fill placed over the old slab.

A homeowner who chooses Technique 1 may decide to build a new concrete slab floor instead of a wood floor (Figure 14). When this option is chosen, compacted fill dirt or gravel is placed on top of the old slab and the new slab floor is poured on top. Because the area below the new floor is filled with dirt or gravel, wall openings are not required.

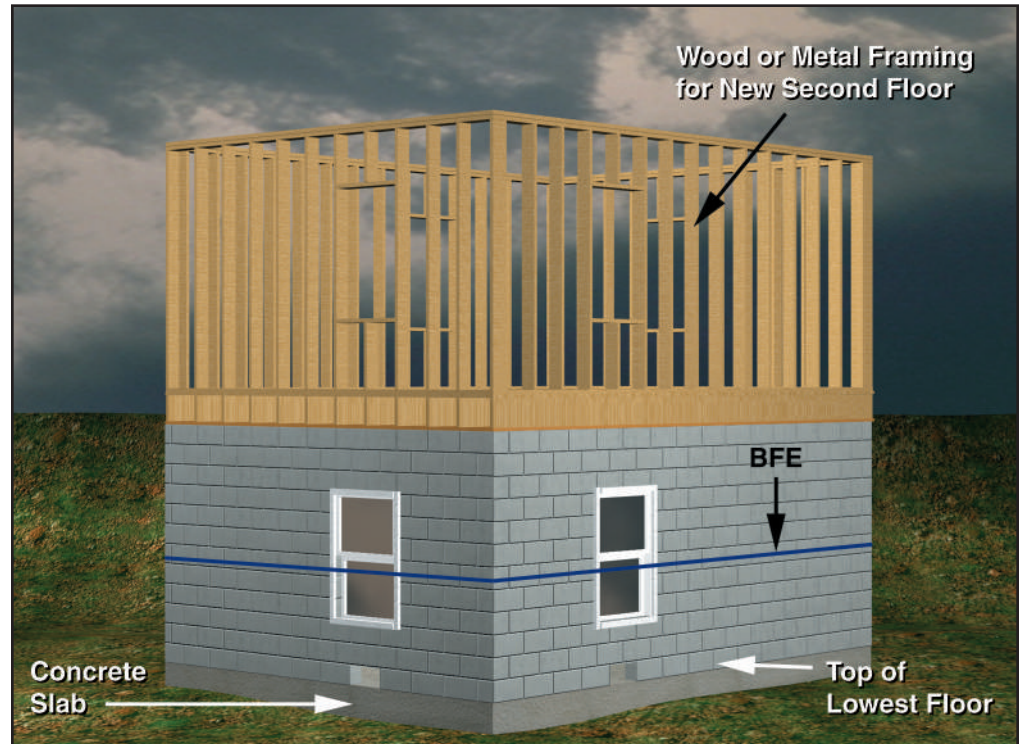
The new second-story floor and walls are built on top of the existing lower story.

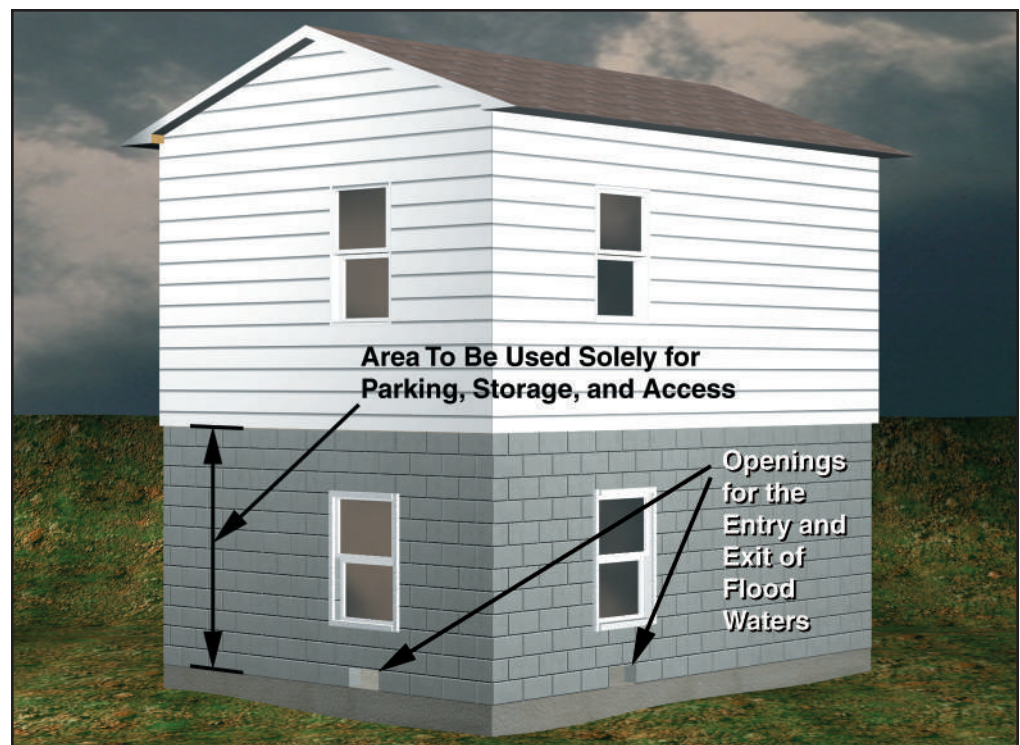
The new second-story walls are covered with siding or stucco.

Some homeowners prefer that the second story be constructed of masonry, but wood- or metal-framing is more common, primarily because it is lighter and less expensive. The roof is replaced, and blocks are removed from the walls to allow flood waters to enter and exit. Exterior sheathing is then added to the framed walls of the second story, the new windows are installed, and siding or stucco is applied to the sheathing (Figure 16).

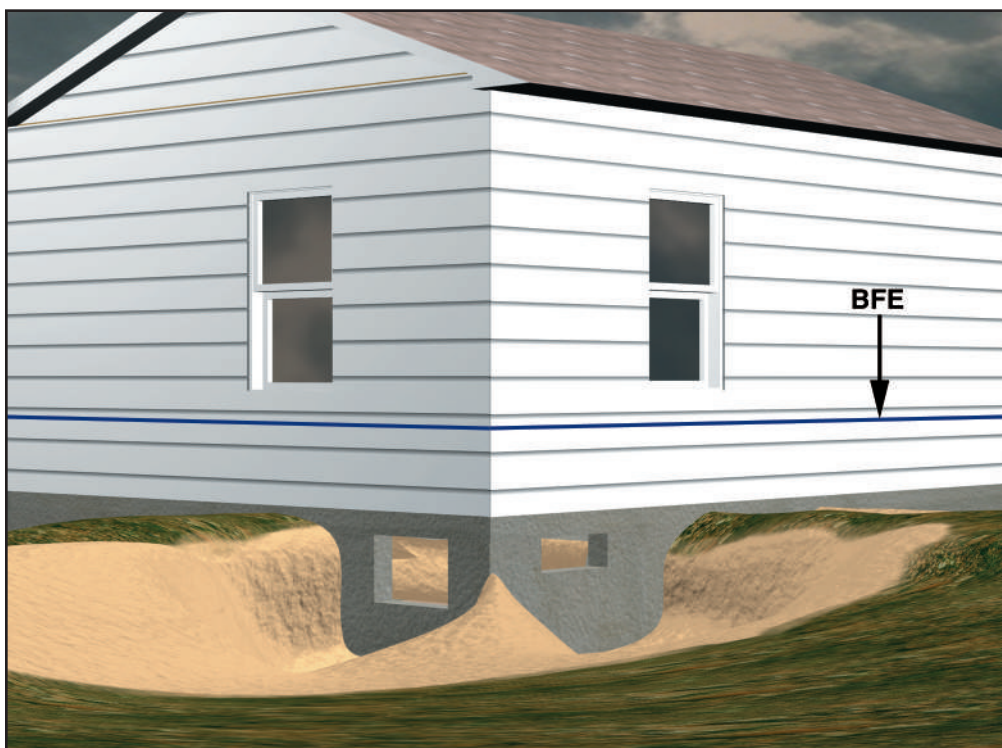
**Figure 17**  
Trenches and tunnels under the slab provide access for the jacks and I-beams that will lift the house.

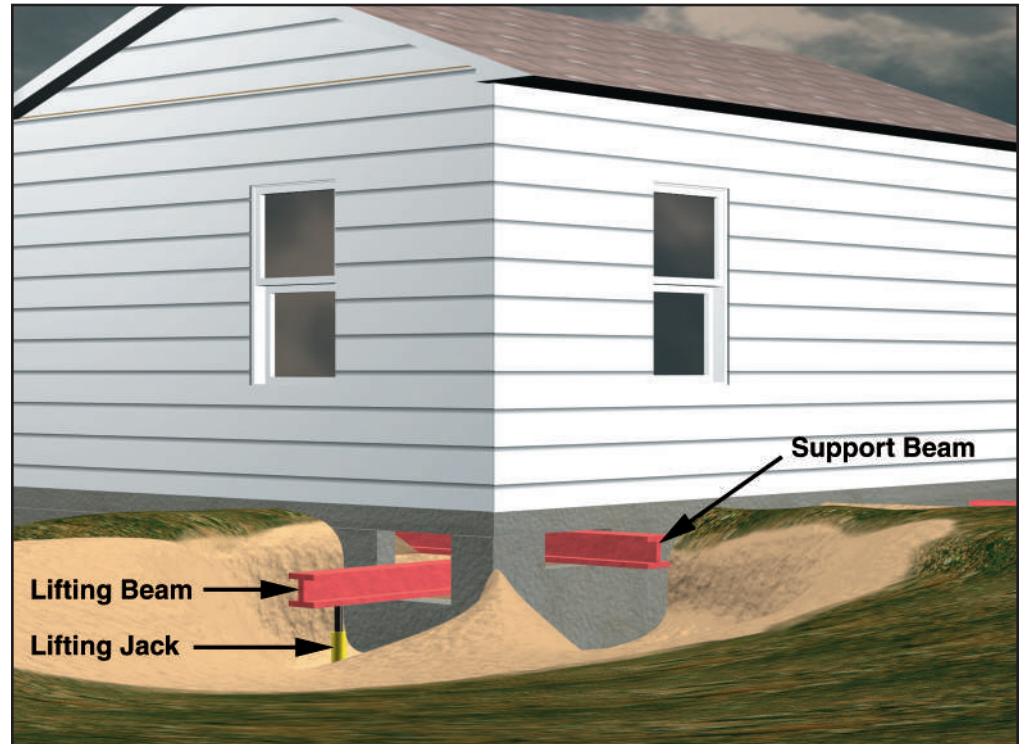
**Figure 18**  
With I-beams and jacks in place, the house is ready to be lifted.

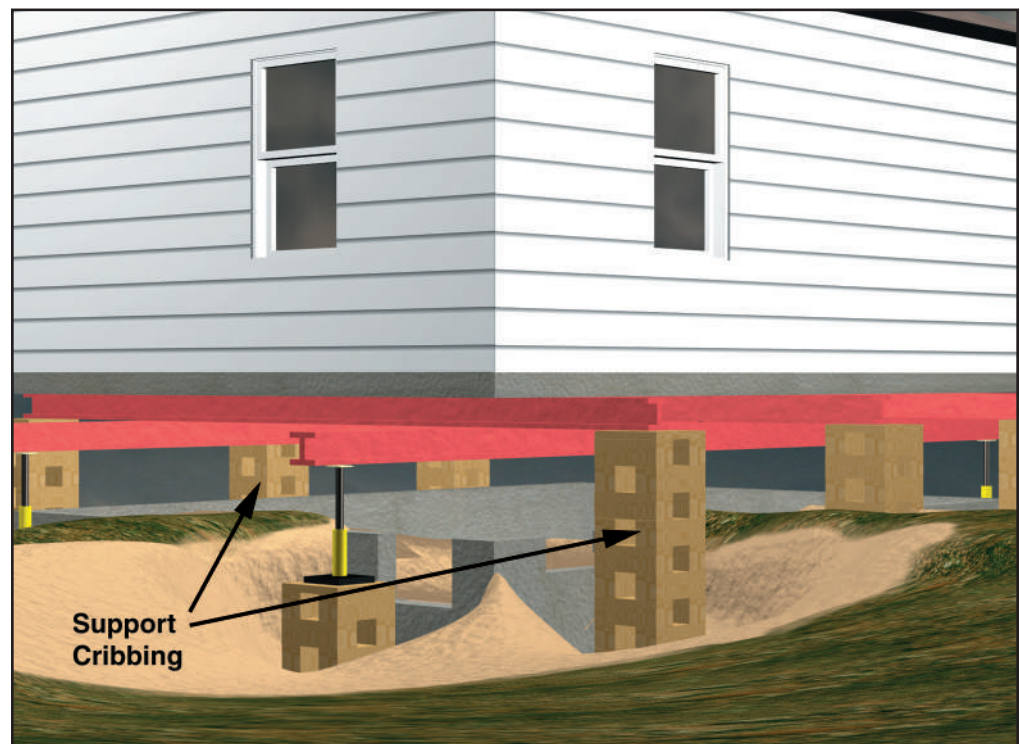
**Figure 19**  
The house is temporarily supported on cribbing.

The house is then jacked up. When the jacks have extended as far as possible, the house must be supported temporarily while the jacks are raised. Both the house and the jacks are usually supported on “cribbing”—temporary piles of crisscrossed timbers (Figure 19). The jacks are then used to raise the house higher.

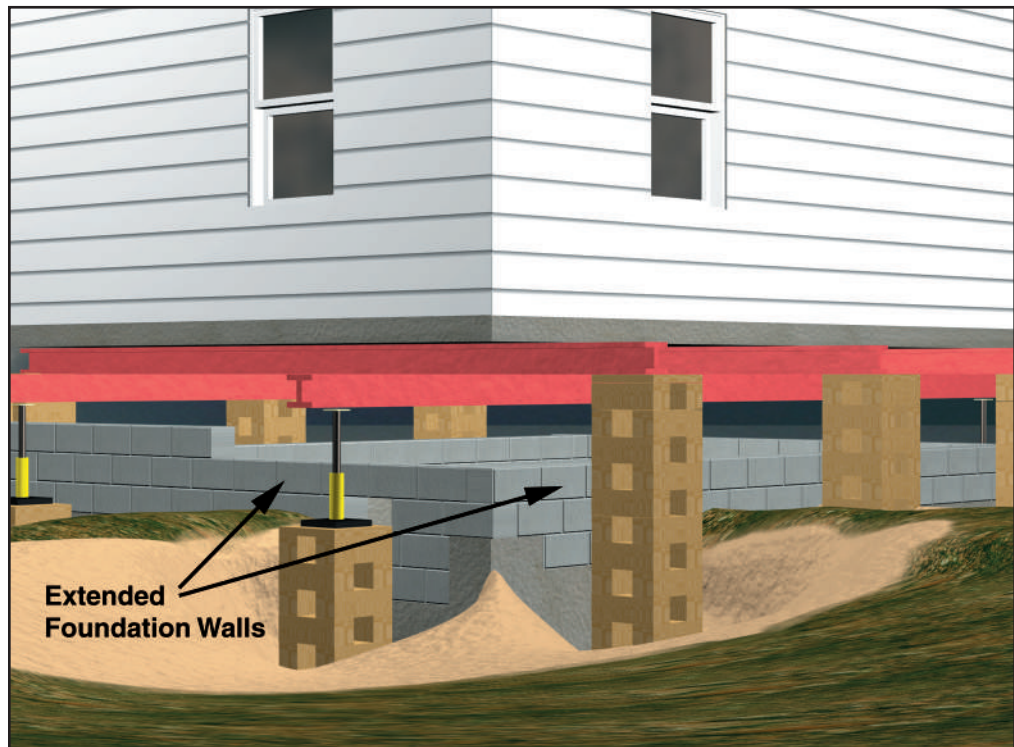
**Figure 20**  
New, extended  
foundation walls are  
constructed with  
concrete blocks.

This process is repeated until the house is raised to the desired height. The foundation walls are then extended upward with additional rows of concrete block (Figure 20). As in the previous techniques, openings are made in the walls within 1 foot of the ground so that flood waters will be able to flow into and out of the area below the elevated floor. The jacks and beams are removed, and the openings left around the beams are filled with blocks (Figure 21).

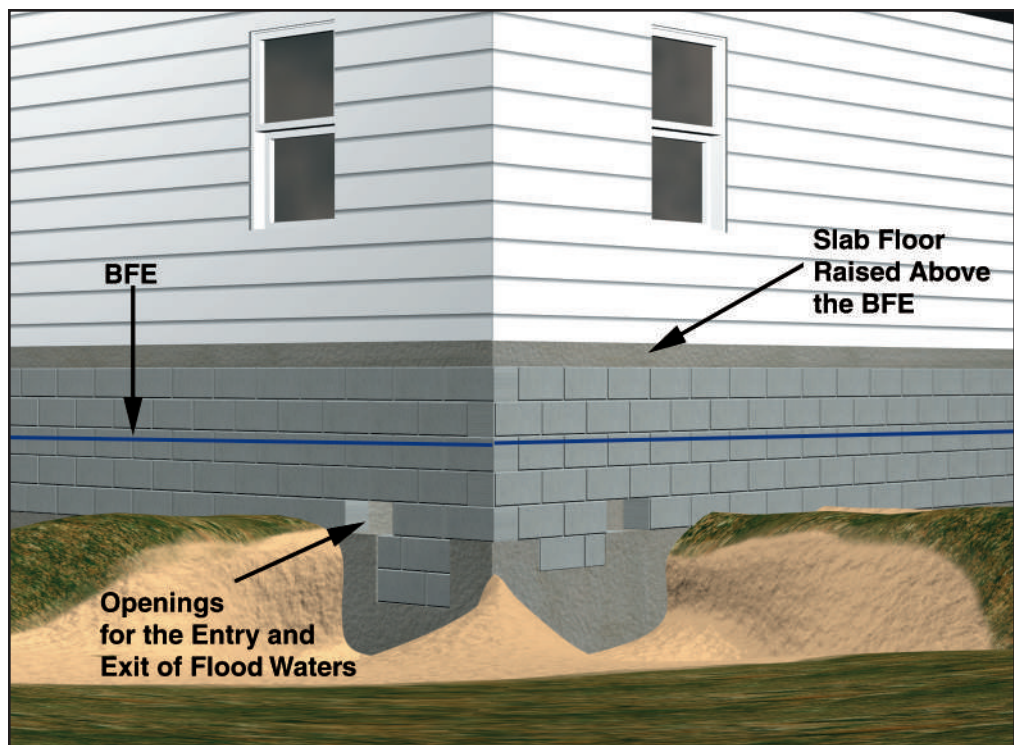
**Figure 21**  
Elevated house and  
slab on new, extended  
foundation walls.

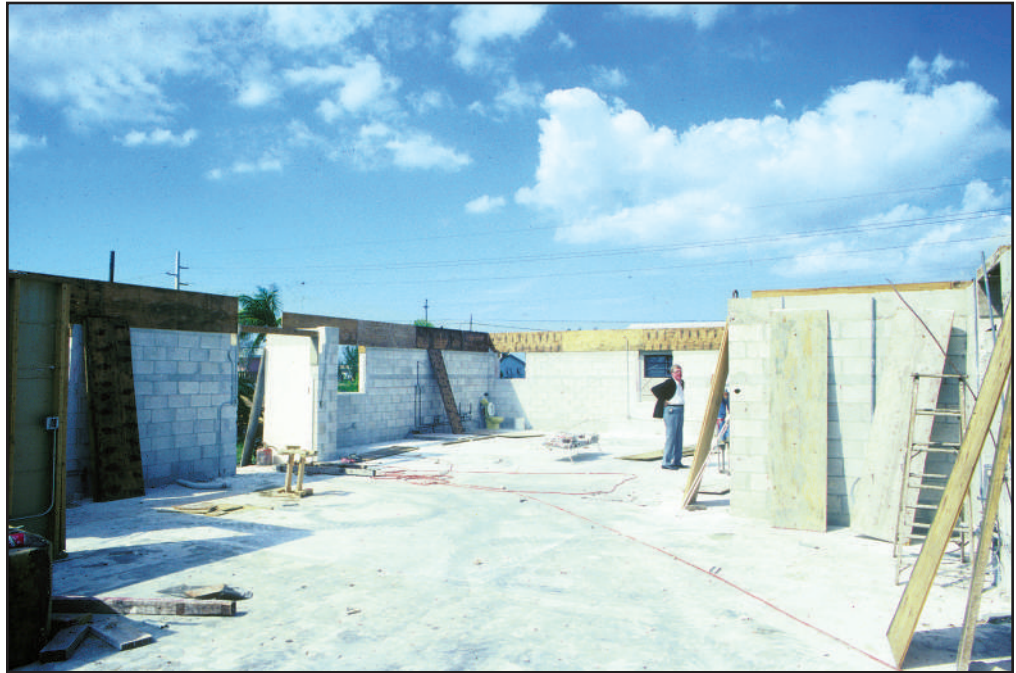
**Figure 40**

After the roof was removed and the storm-damaged interior gutted, the walls of the house were extended upward and a new bond beam added at the top.

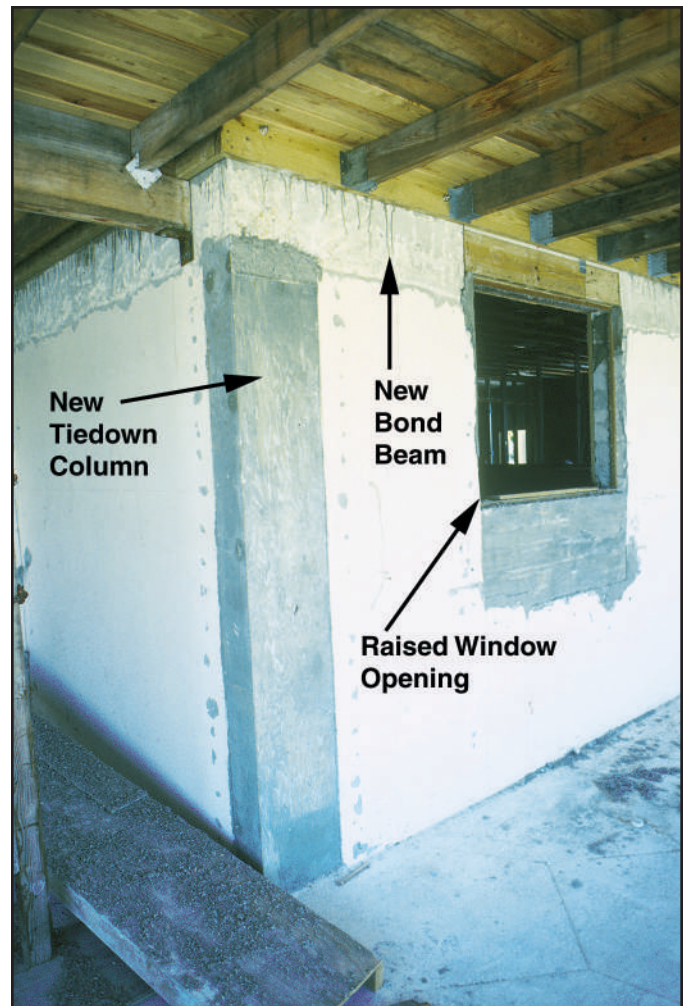
**Figure 41**

Note the new bond beam at the top of the extended wall, the new concrete tiedown column at the corner, and the raised window opening.

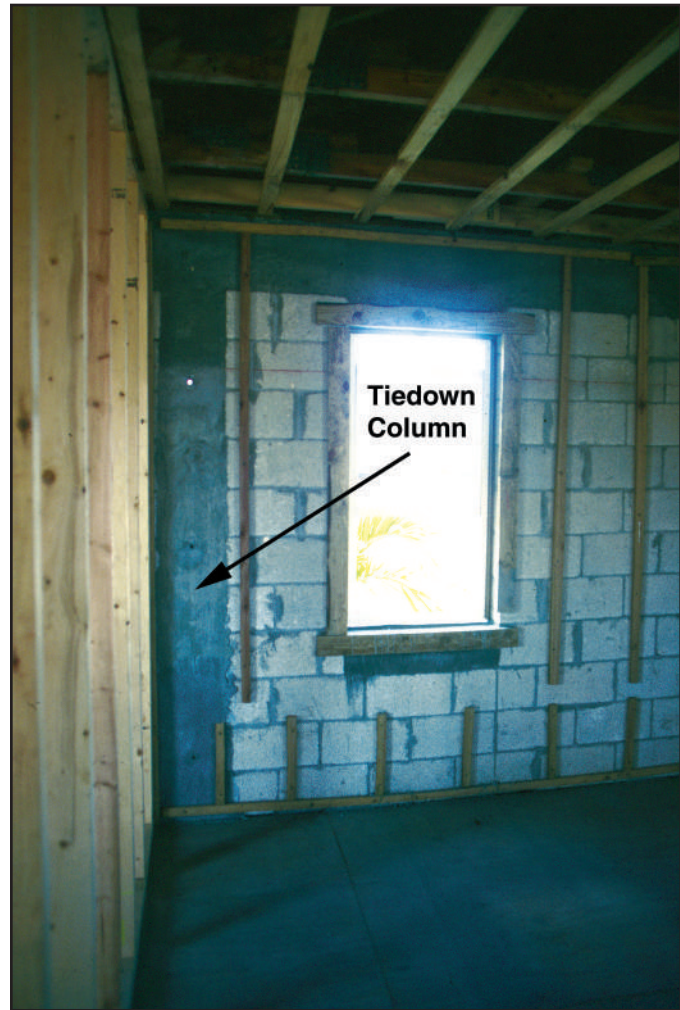
**Figure 46**  
Concrete tiedown columns, such as the one to the left of the window in this photograph, were also used in this house.

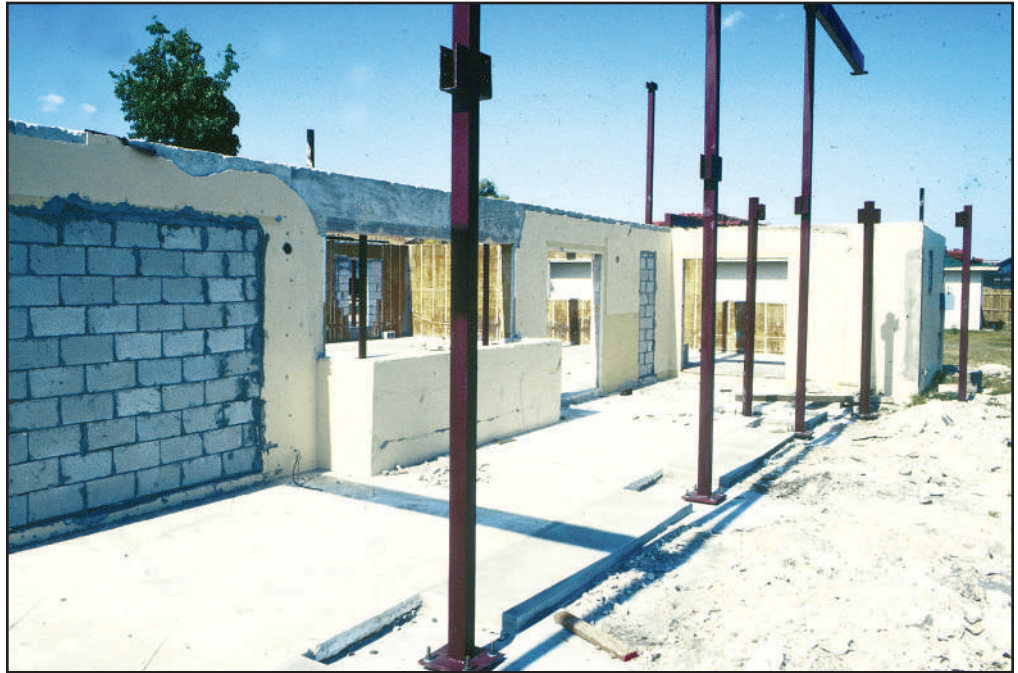
**Figure 52**

The existing first-story walls have been strengthened by the addition of concrete block. Metal columns and beams have been added to help support the new second story.

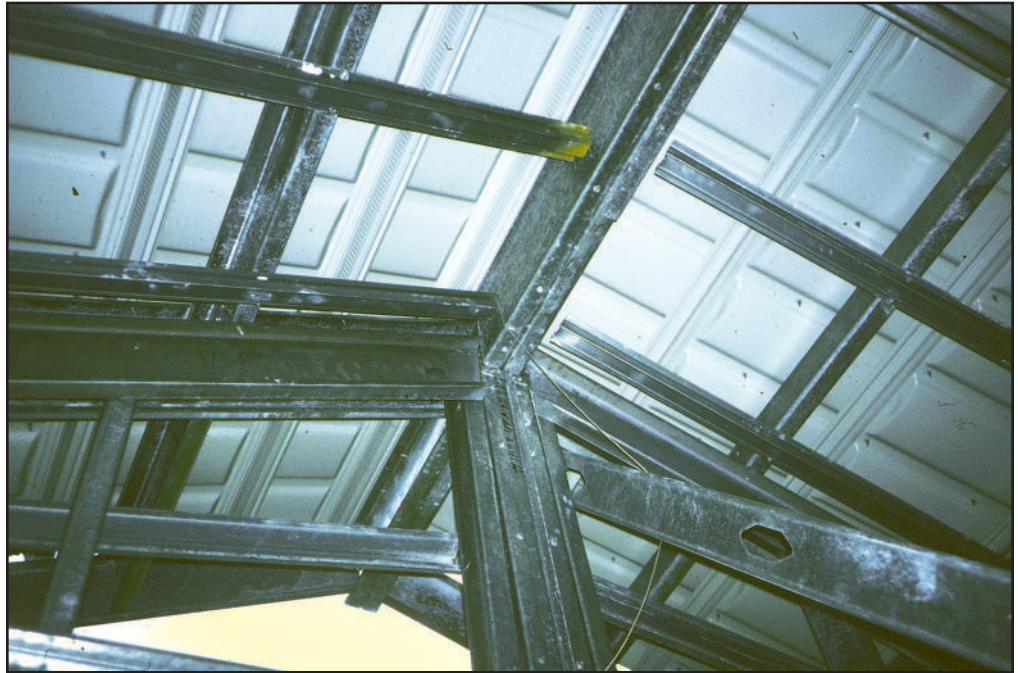
One advantage of metal framing is its relatively light weight. An additional advantage is that the screws used to attach metal-frame components provide strong connections.

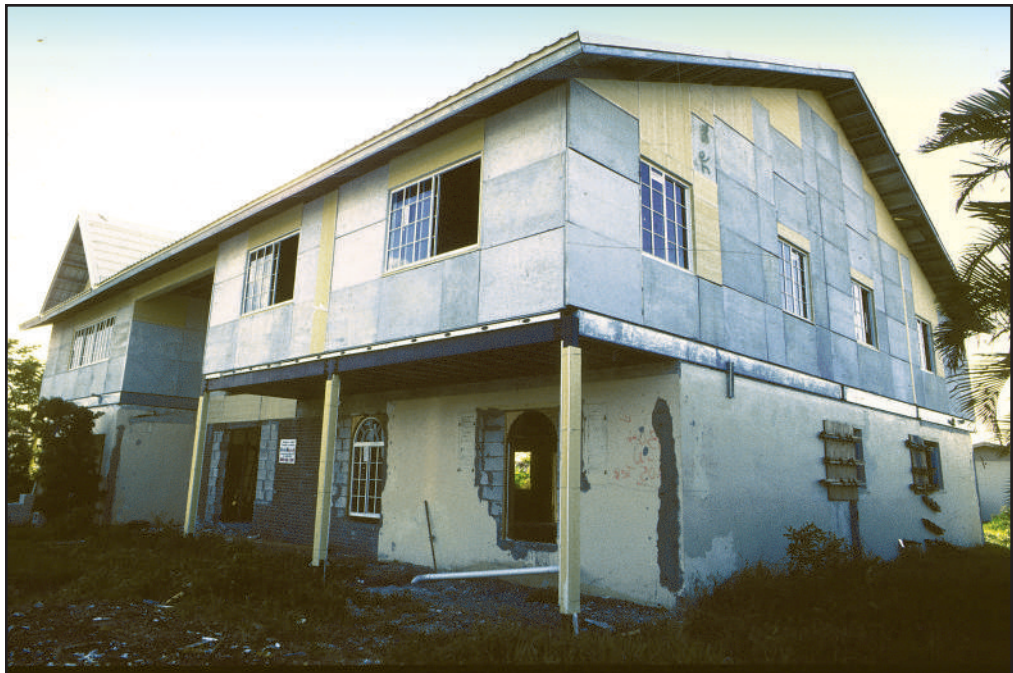
**Figure 59**

The exterior  
walls consist of  
prefabricated  
concrete panels.  
Innovative techniques  
such as those  
employed in this  
project are helping  
homeowners who  
need practical and  
economical methods  
of repairing and  
protecting their  
houses.

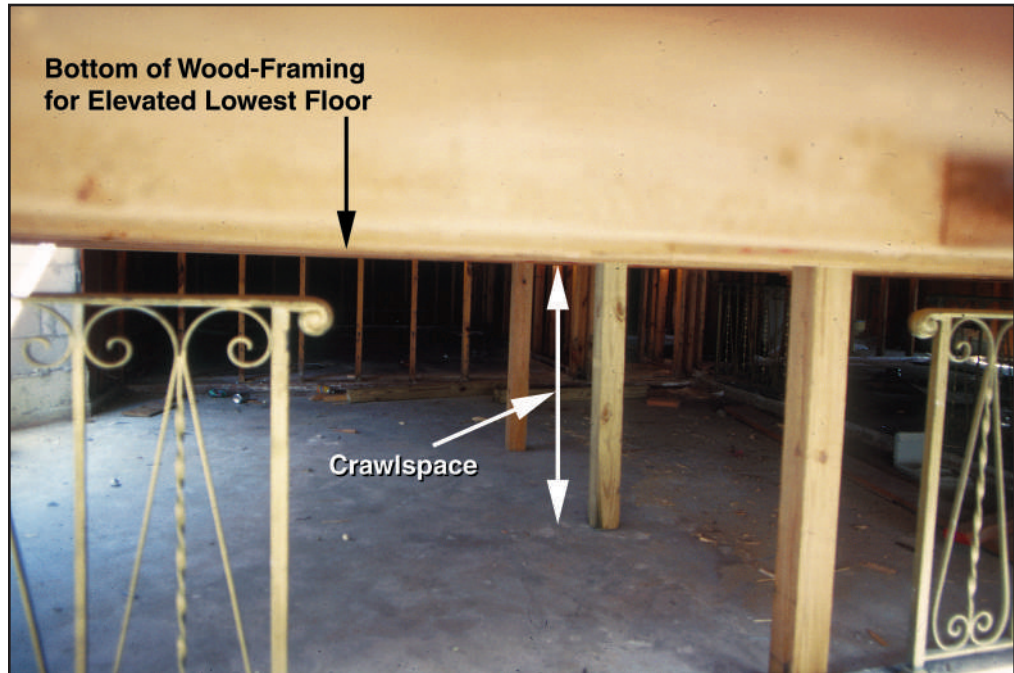
**Figure 68**

Rather than install a new concrete slab on compacted fill, the owner of this house chose to build a new wood-frame floor above the old concrete slab. This method creates a crawlspace below the new floor.

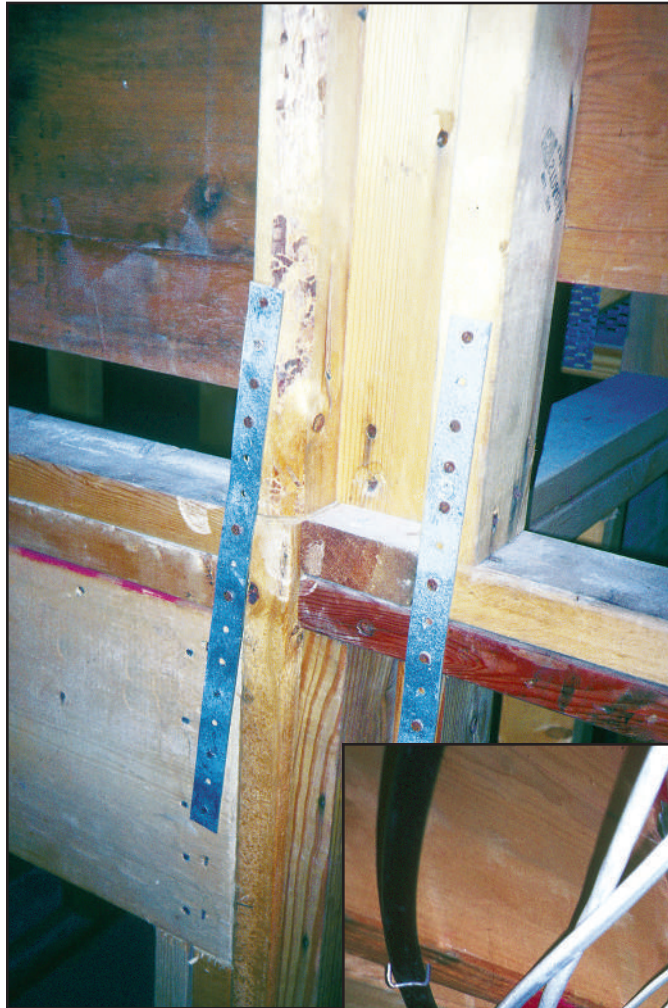
**Figure 70**

Metal hurricane straps are used to tie the structural members together and create a continuous load path from the roof to the foundation.

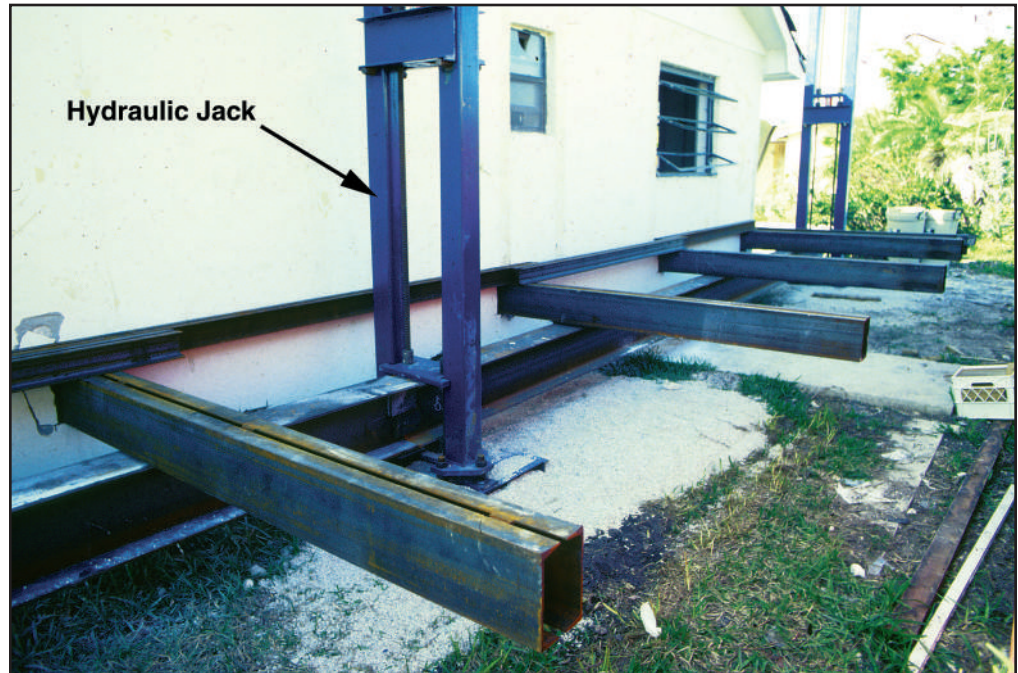
**Figure 74**

In this variation of Technique 3, steel beams are inserted through the walls of the house rather than under the slab. The beams span the length and width of the house and cross one another inside to create a grid. Outside the house, the beams rest on larger beams that will be raised with hydraulic jacks.

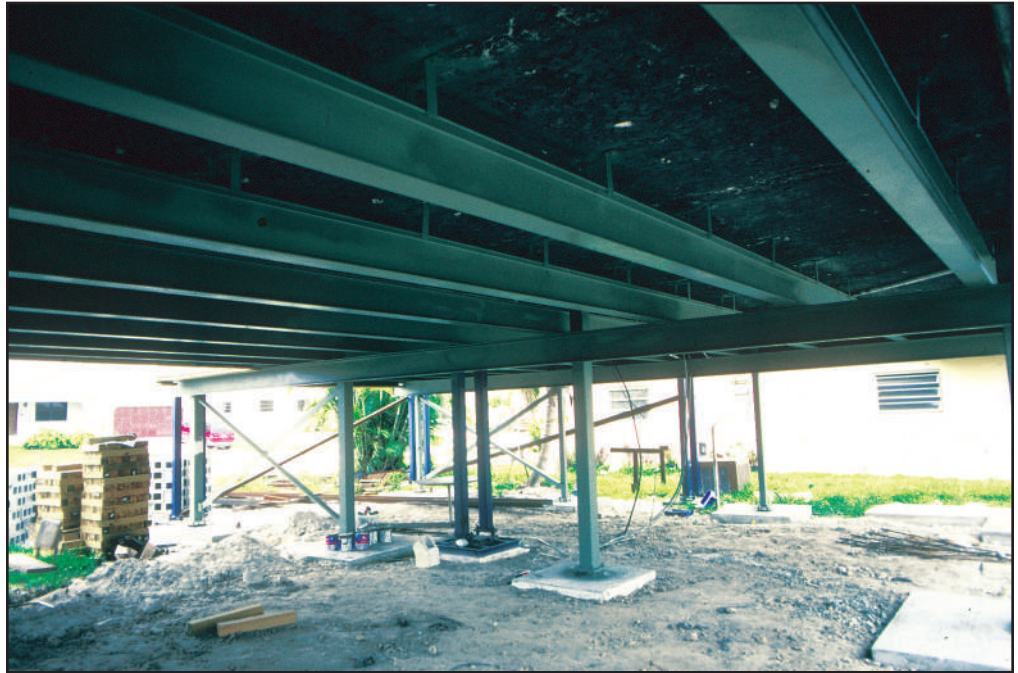
**Figure 82**

While the jacks and beams supported the house, new steel foundation members were installed below.
